AFT Case Study

SC6

- **Reduced Breaks on paper machine**
- **Improved Formation**

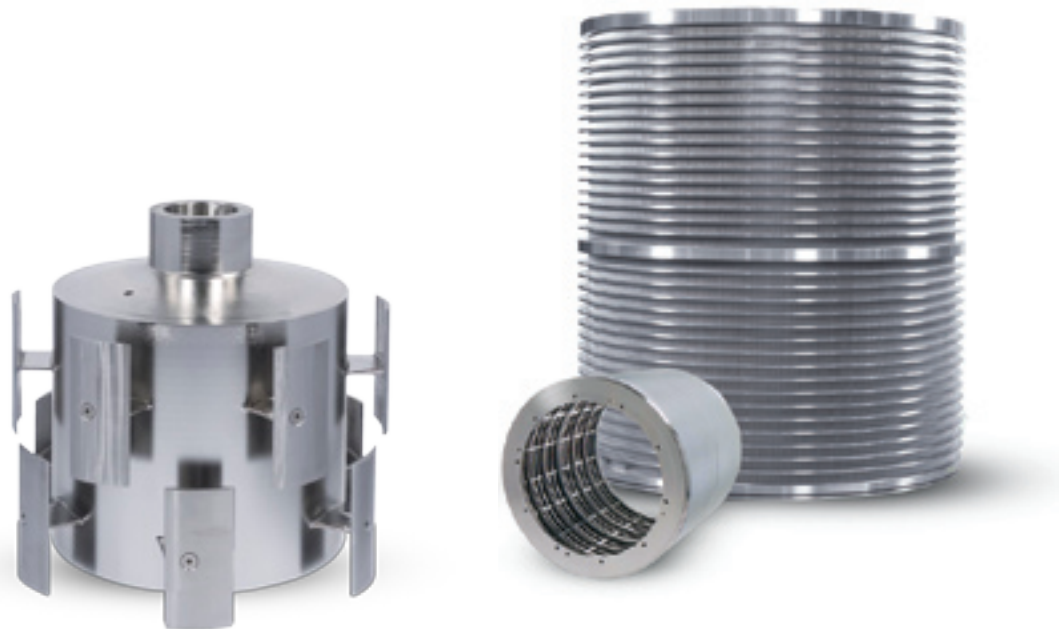
AFT MacroFlow™ screen cylinders represent the state-of-the-art in screening technology. The advanced wedgewire design provides both the increased open area afforded by a continuous slot – and superior strength relative to a resistance-welded wedgewire construction. AFT MacroFlow™ screen cylinders are also distinguished by the industry's largest selection of wire sizes, which enables each application to be optimized. The combination of its non-welded construction and “headbox quality” finish eliminates the formation of strings or deposits, which would be harmful to headbox applications.
